HAMPTON HARBOR BRIDGE

Public Information Meeting

January 30, 2019

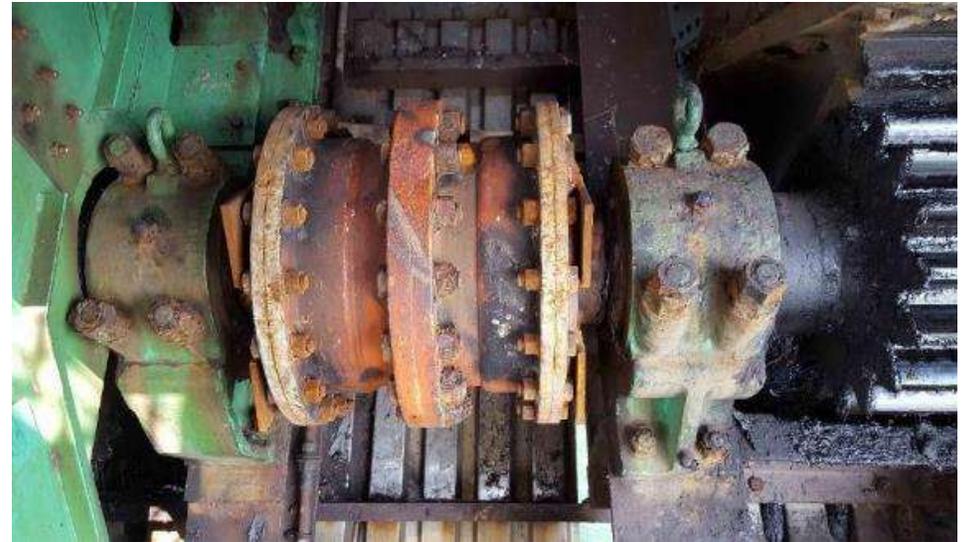
Deteriorated pinion and coupling, key elements of lift mechanism – Interim Repairs in 2018

- Structurally deficient and functionally obsolete bridge
- Many original mechanical components and outdated electrical system
- Substandard shoulder and sidewalk widths

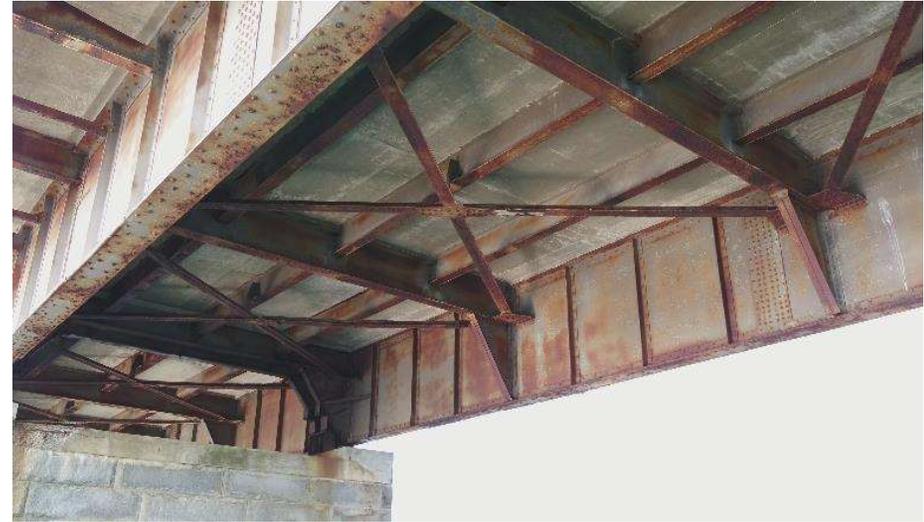
Typical Bridge Underside

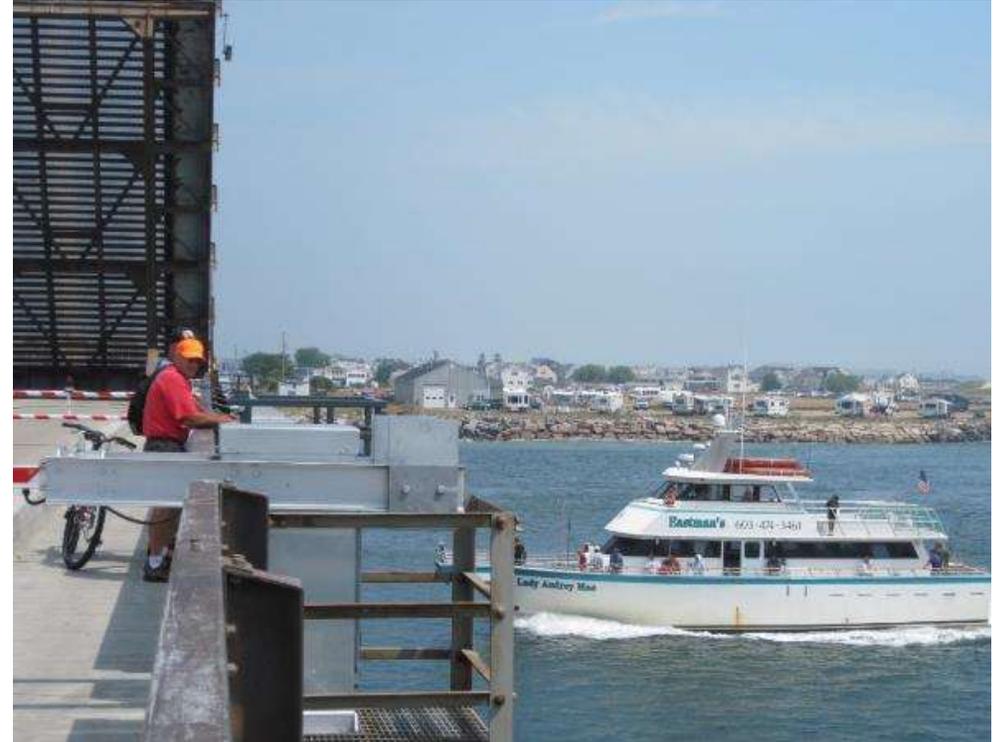
Bridge open to allow for vessel passage

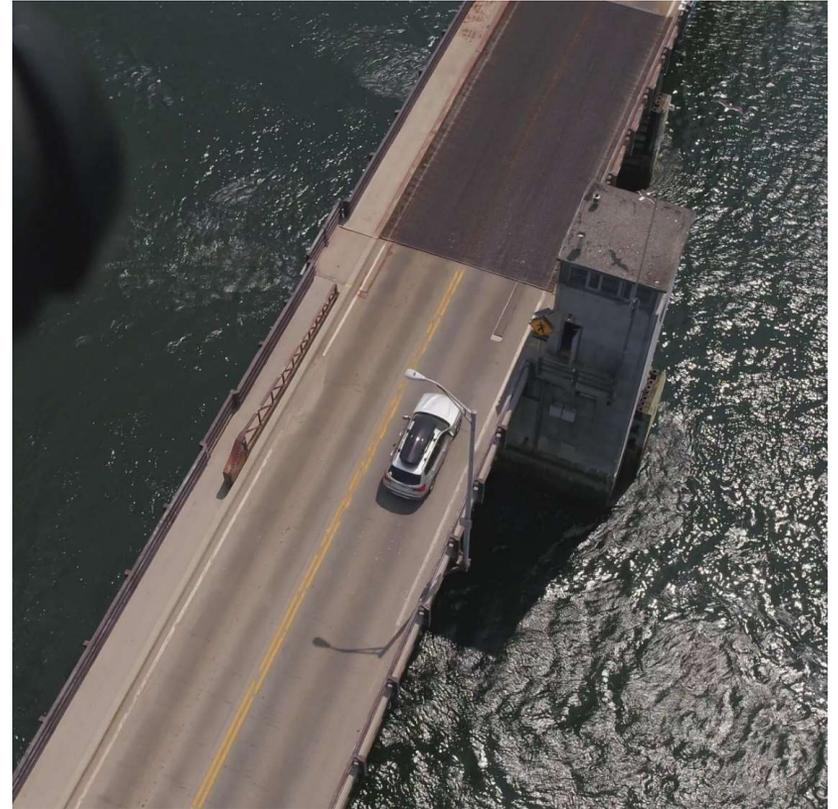
Looking downward at bascule span

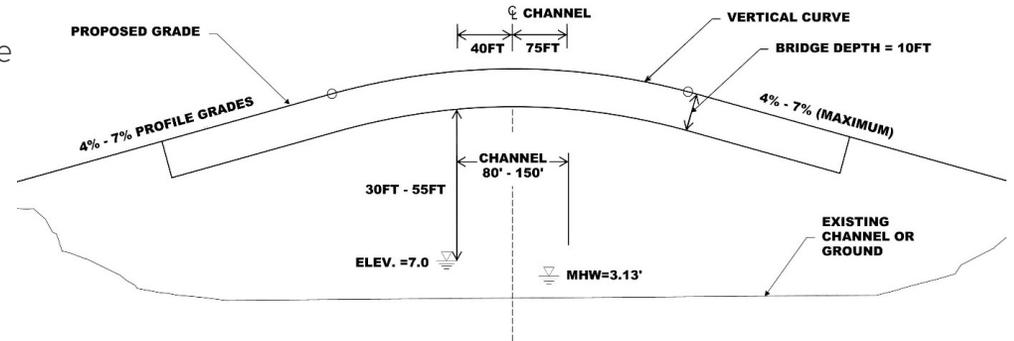
Roadway Slope	Serviceability for Ped and Bike
3%-4%	Desirable for Pedestrians and Bicyclists
5%-6%	Acceptable Per Code Requirements
7% or More	Less Desirable

- Roadway slope
 - ▶ Steeper slopes reduce approach impacts and improve navigation
 - ▶ Flatter slopes improve vehicular, bicyclist and pedestrian access
- Vessel Navigation Clearances
 - ▶ Higher clearances improve navigation and reduce impacts to roadway traffic
 - ▶ Lower clearances reduce approach impacts
 - ▶ Sea Level Rise
- East vs West vs Existing Alignment
 - ▶ Impacts of both alignments must be considered
- Impacts on Roadway Approaches
 - ▶ Informs impacts to resources, right-of-way and facilities on approaches
- Constructability and Cost
 - ▶ Full cost estimates not developed at this stage, but qualitatively considered

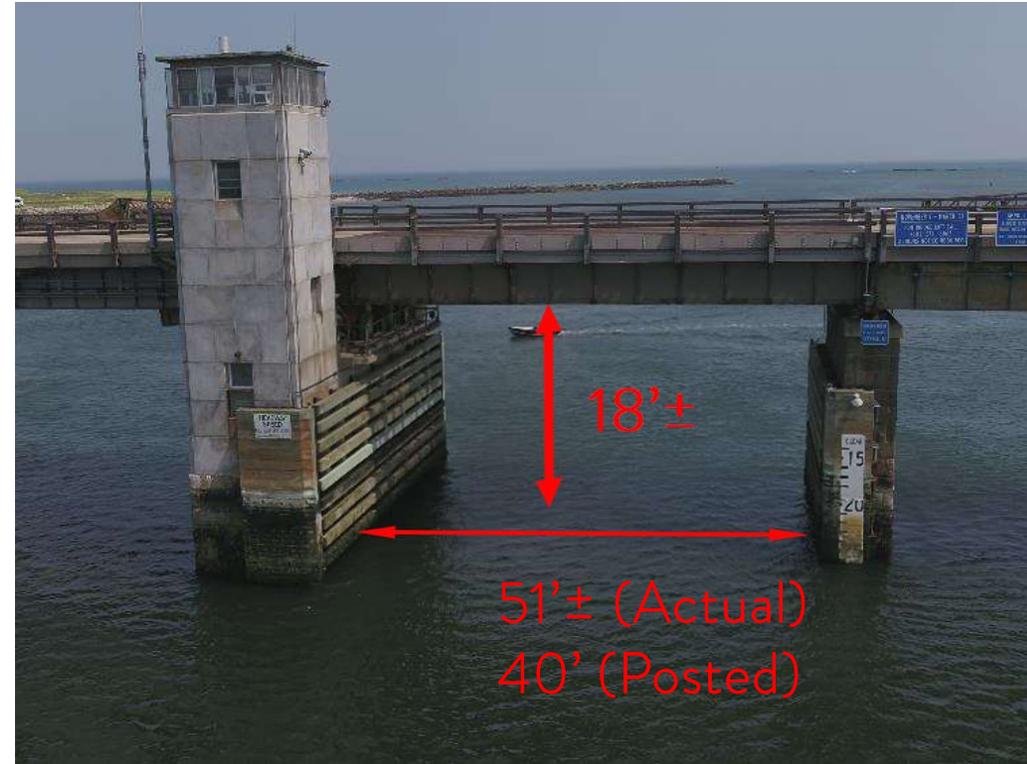
Existing Navigational Clearances per Coast Surveys at Mean High Water

- Bascule Bridge
 - ▶ Height increases do not need to pass all vessels
 - ▶ Horizontal Clearance allows clearance of USACE dredge equipment
 - ▶ Decreases required lifts
- Fixed Bridge
 - ▶ Height may restrict future navigation
 - ▶ Must serve needs of navigational users
 - ▶ Future use must be considered
 - ▶ Horizontal Clearance matches navigational channel width

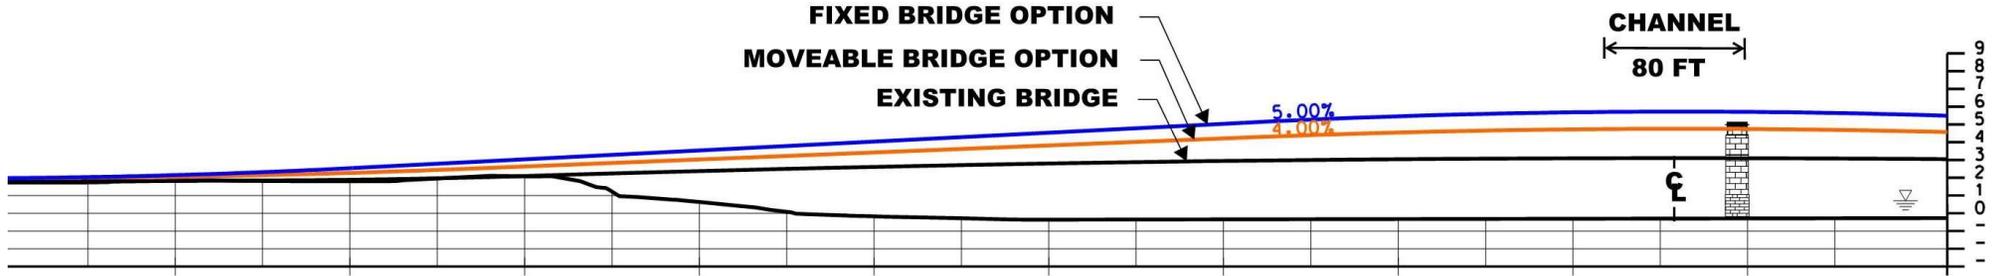
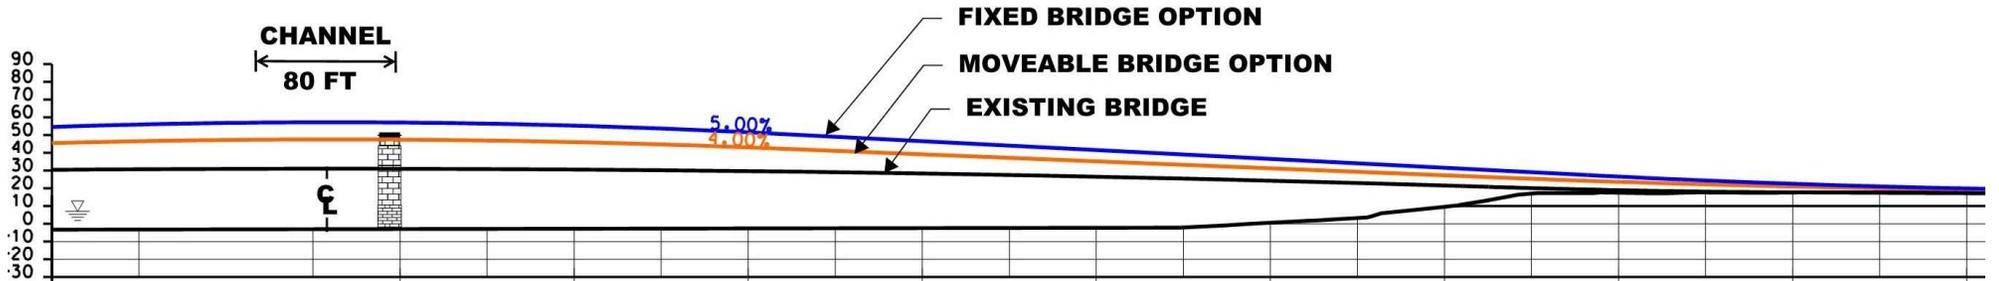
Navigational Vertical Clearance

Vertical Underclearance (from MHW)	Approx. Percentage of Lifts Eliminated
59'	Greater than 97%
44'	Greater than 90%
34'	Greater than 55%
18'	Current Clearance

- Bascule Bridge
 - ▶ Proposed channel clearance: 80' Width, 34' Height with bridge in down position
- Fixed Bridge
 - ▶ Proposed channel clearance: 150' Width, 44' Height
 - ▶ 59' Height considered, not carried forward pending review by agencies
- Clearances include 3.9' Sea Level Rise
 - ▶ “Intermediate-High” range of estimated 2100 rise by NH Coastal Risk and Hazards Commission 2016 Report

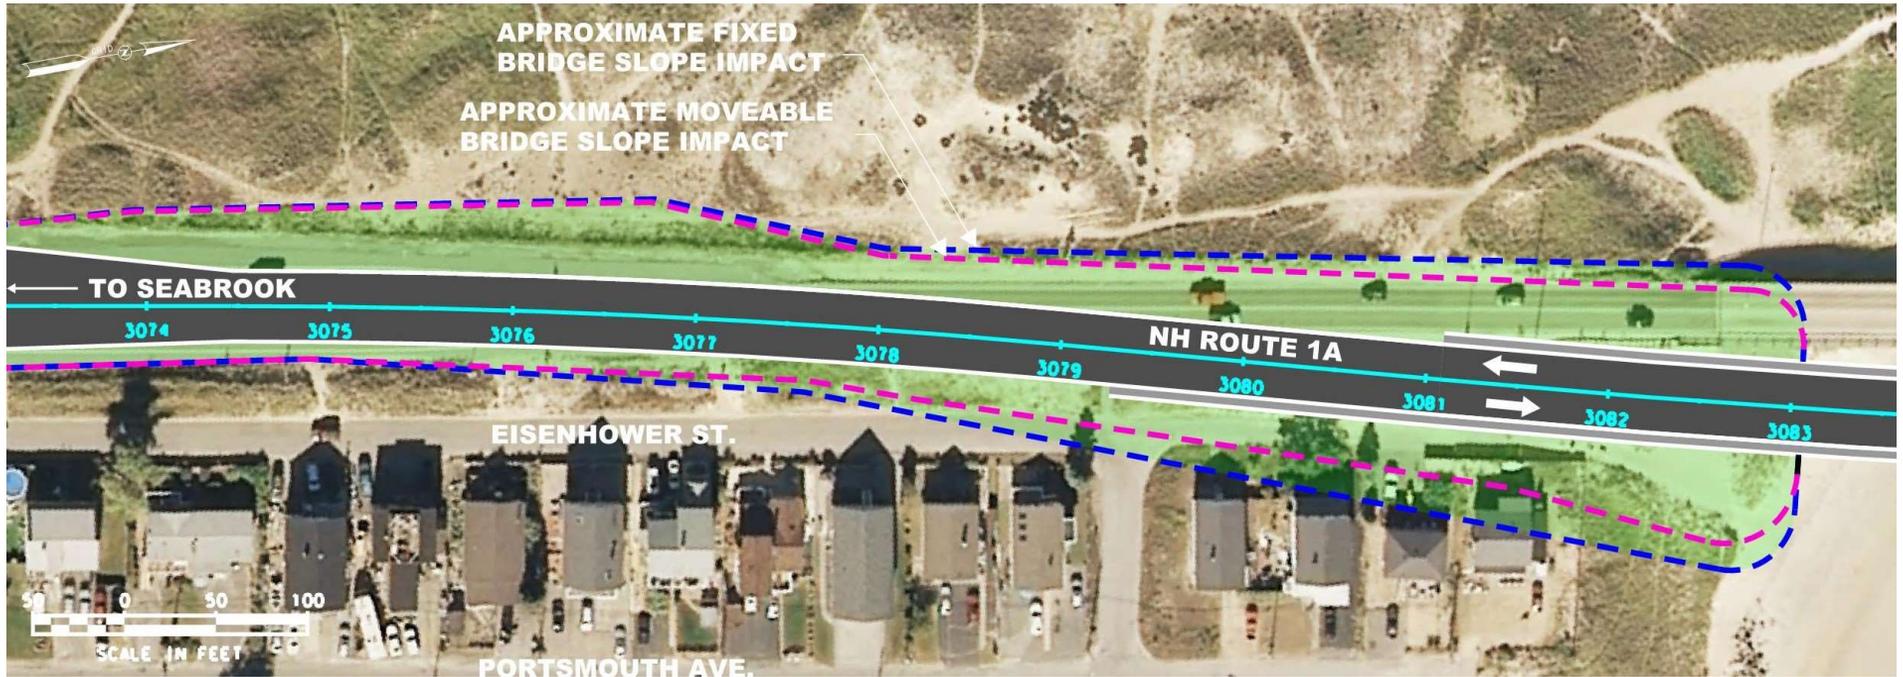
South Approach

Eastern Alignment

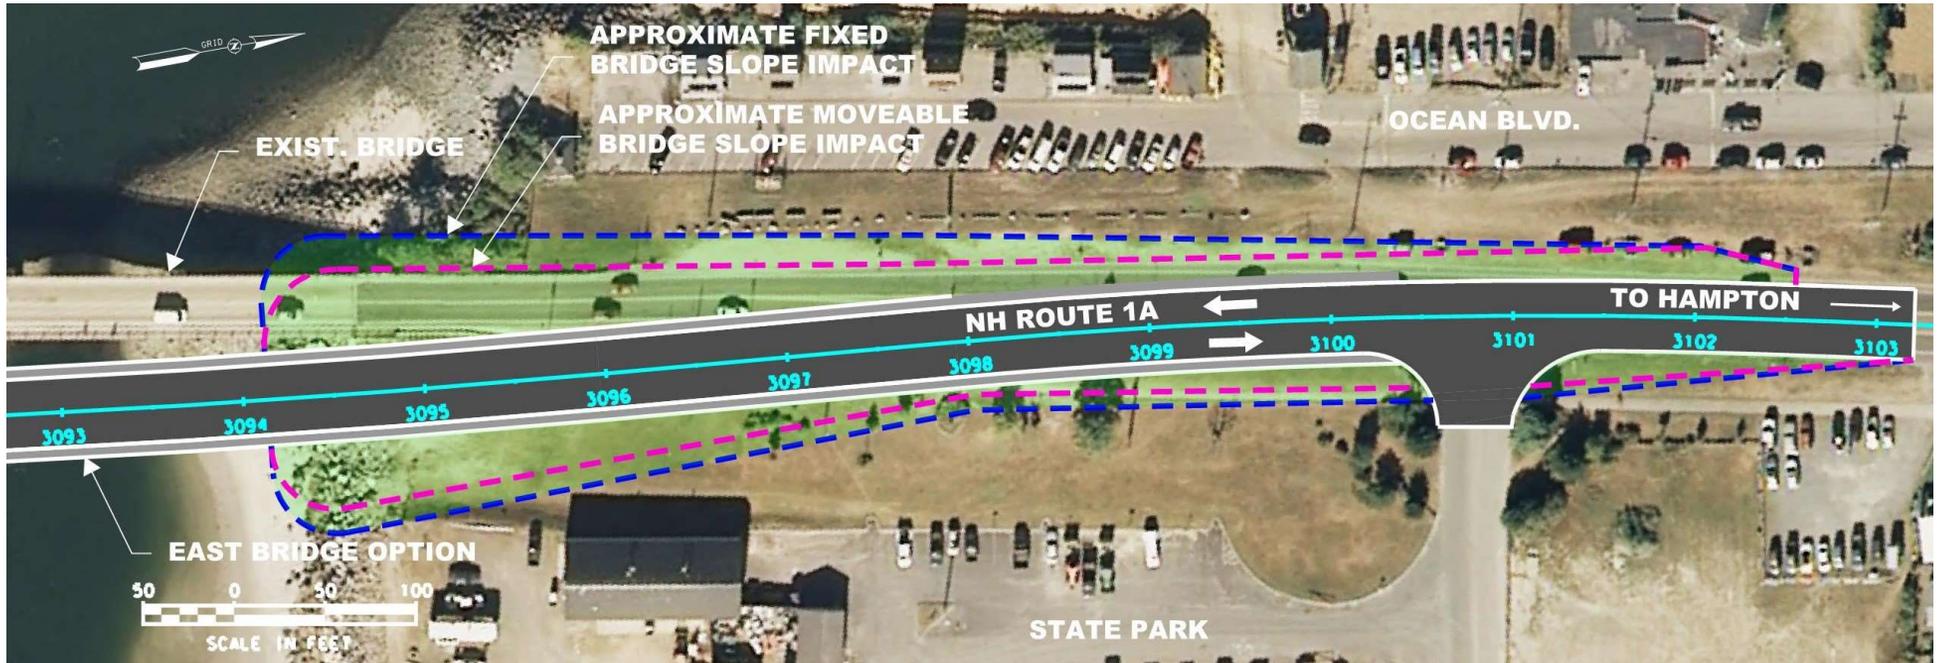
North Approach

Eastern Alignment

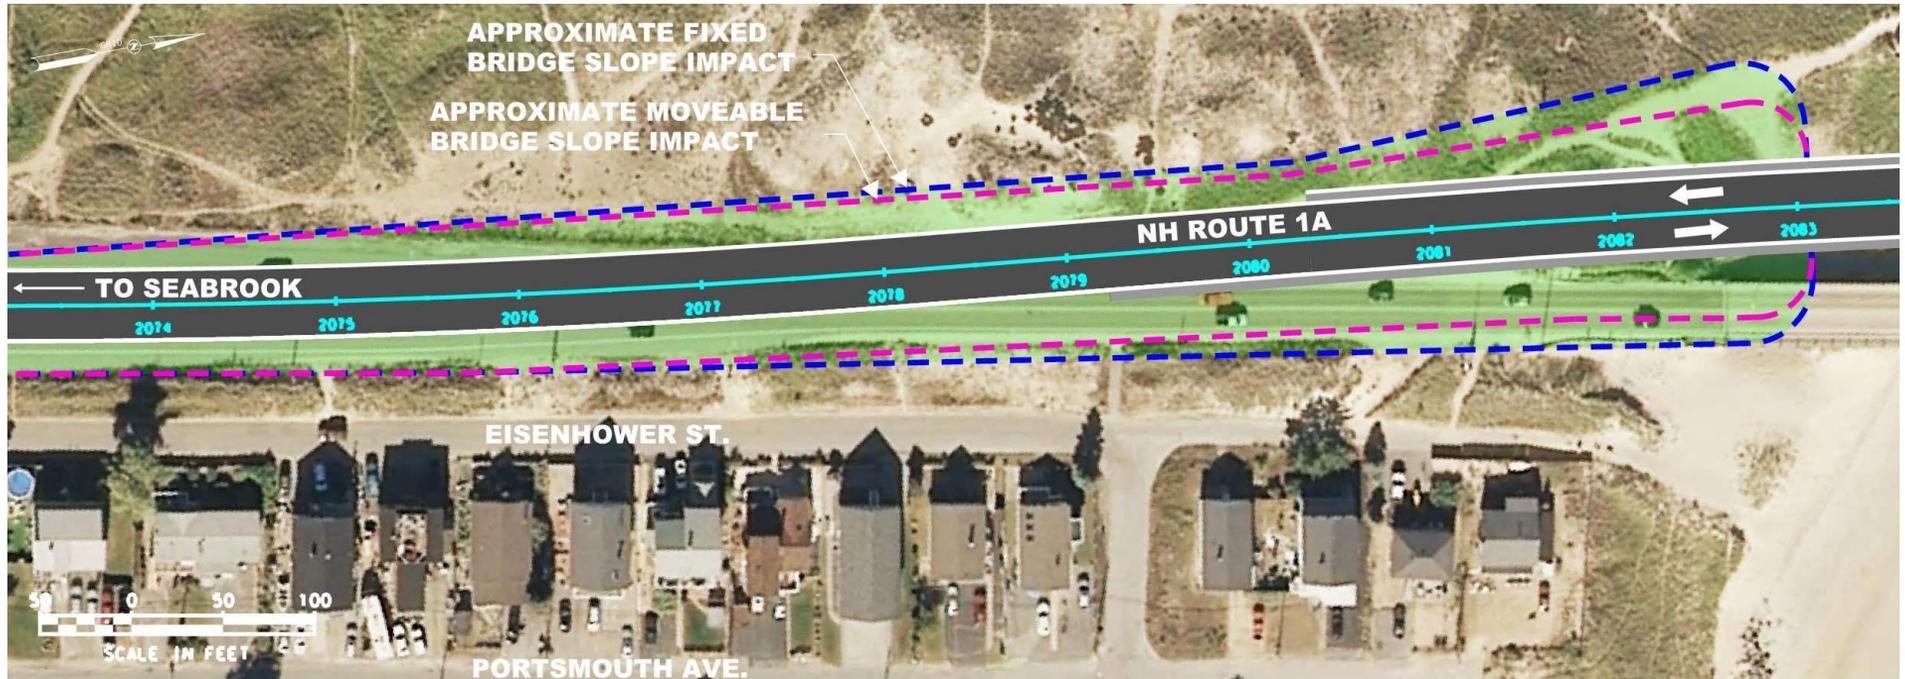
South Approach

Western Alignment

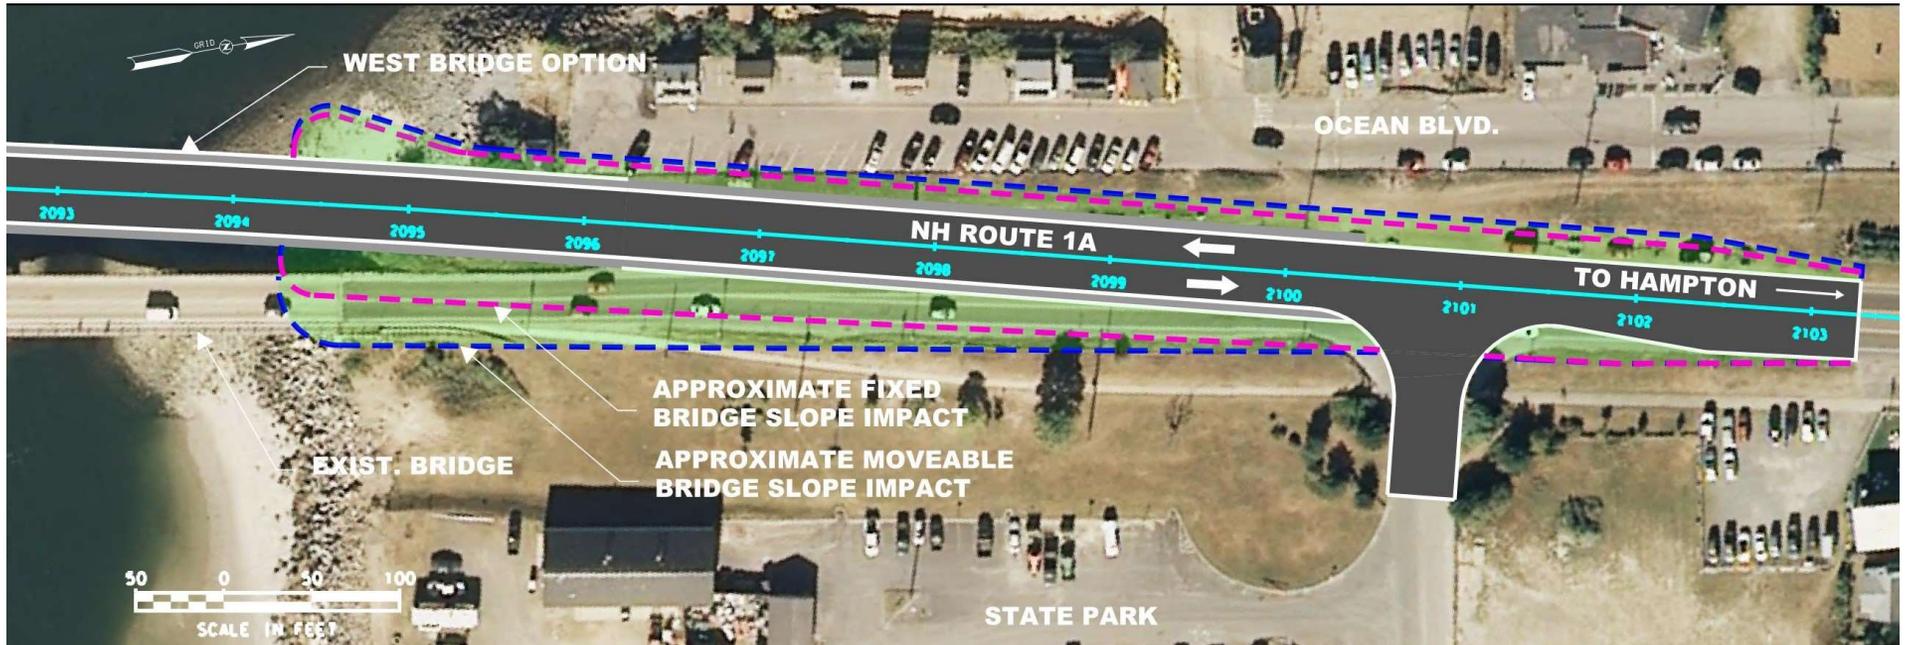
North Approach

Western Alignment

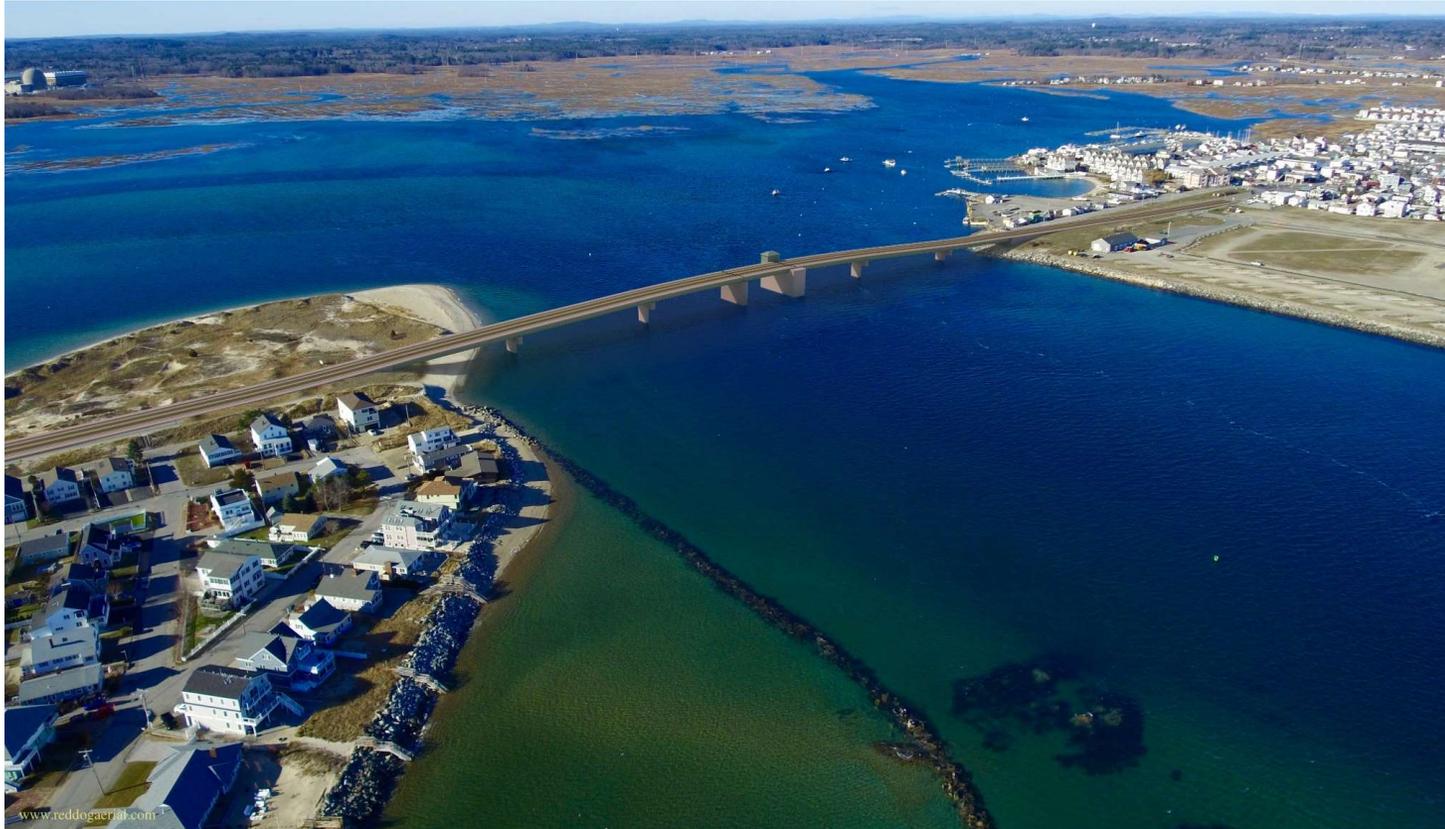
Aerial of Proposed Bascule Bridge

- Provides improved underclearance for vessels
 - ▶ Clears USACE dredging equipment
 - ▶ Reduces lifts by over 50% based on current usage
 - ▶ Does not provide full 150' horizontal clearance
- Bridge will be required to lift and will still affect traffic
- Provides desirable roadway grade – 4% slope
- Smallest Impact on Approaches
 - ▶ Low height increase at abutment: 5' +/-
- Costs
 - ▶ Bascule Bridge - significantly higher capital costs compared to a fixed bridge
 - ▶ Higher risk of costs associated with serviceability – system breakdowns can impact vehicular and vessel traffic
 - ▶ Increased life cycle costs associated with operating the bridge and maintaining mechanical/electrical systems

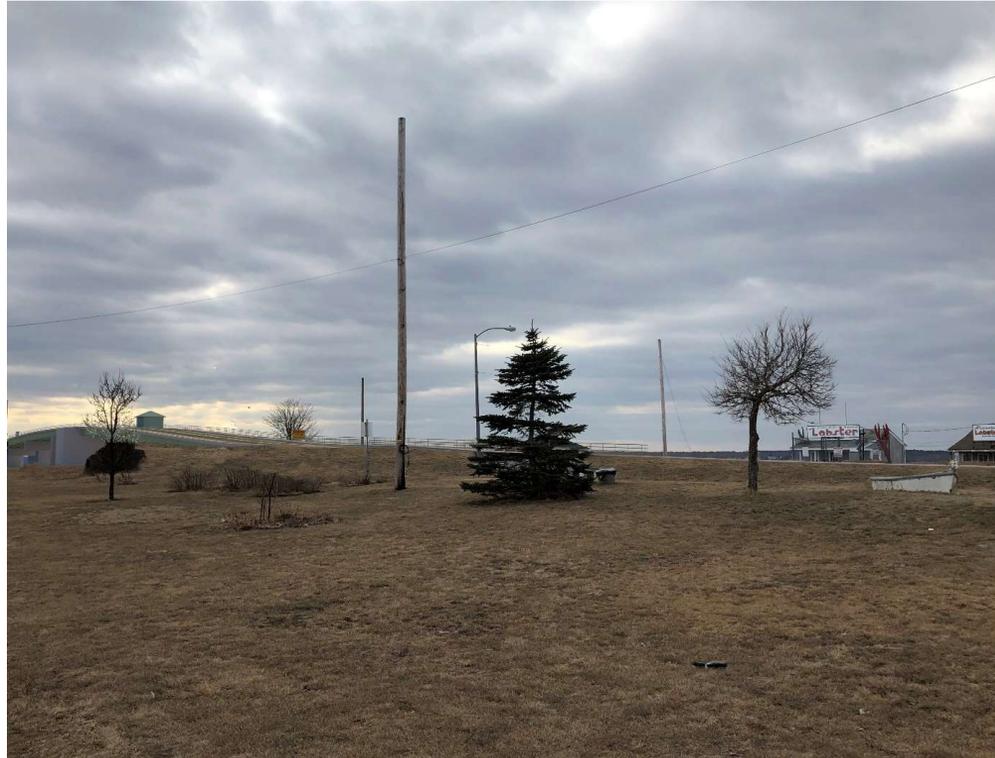
Looking Southwest at North Approach

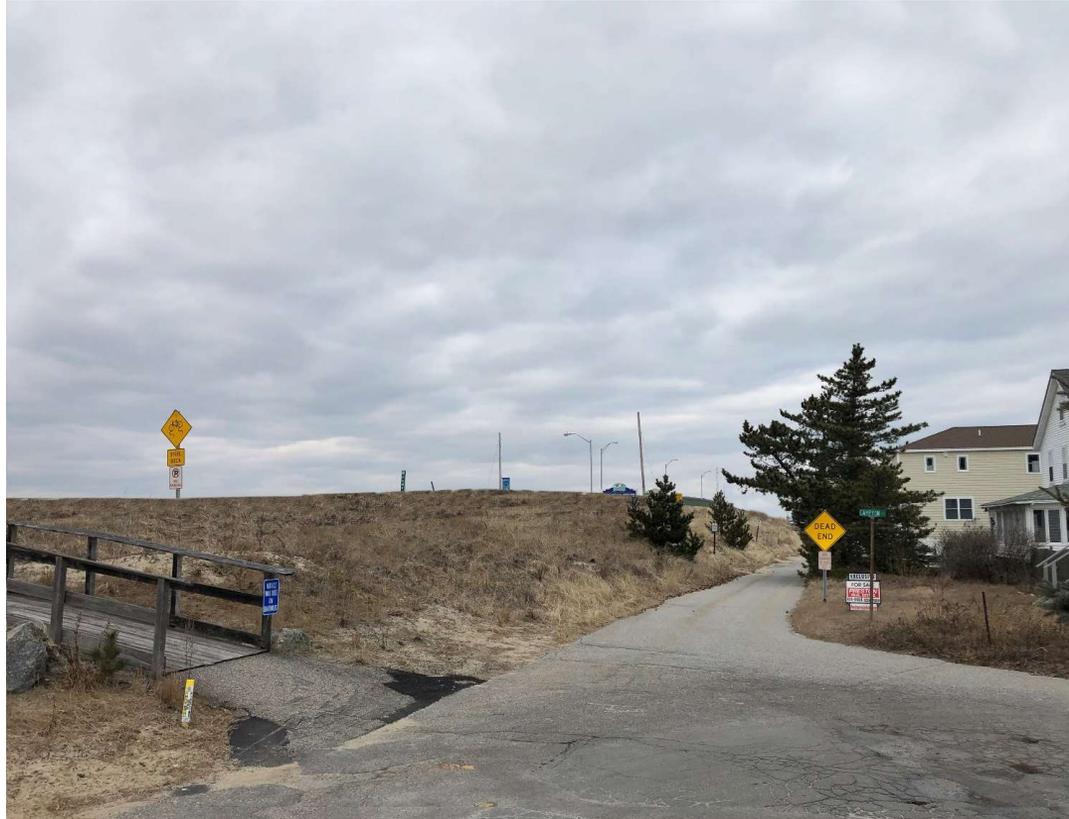
Looking West at South Approach – Proposed Bascule

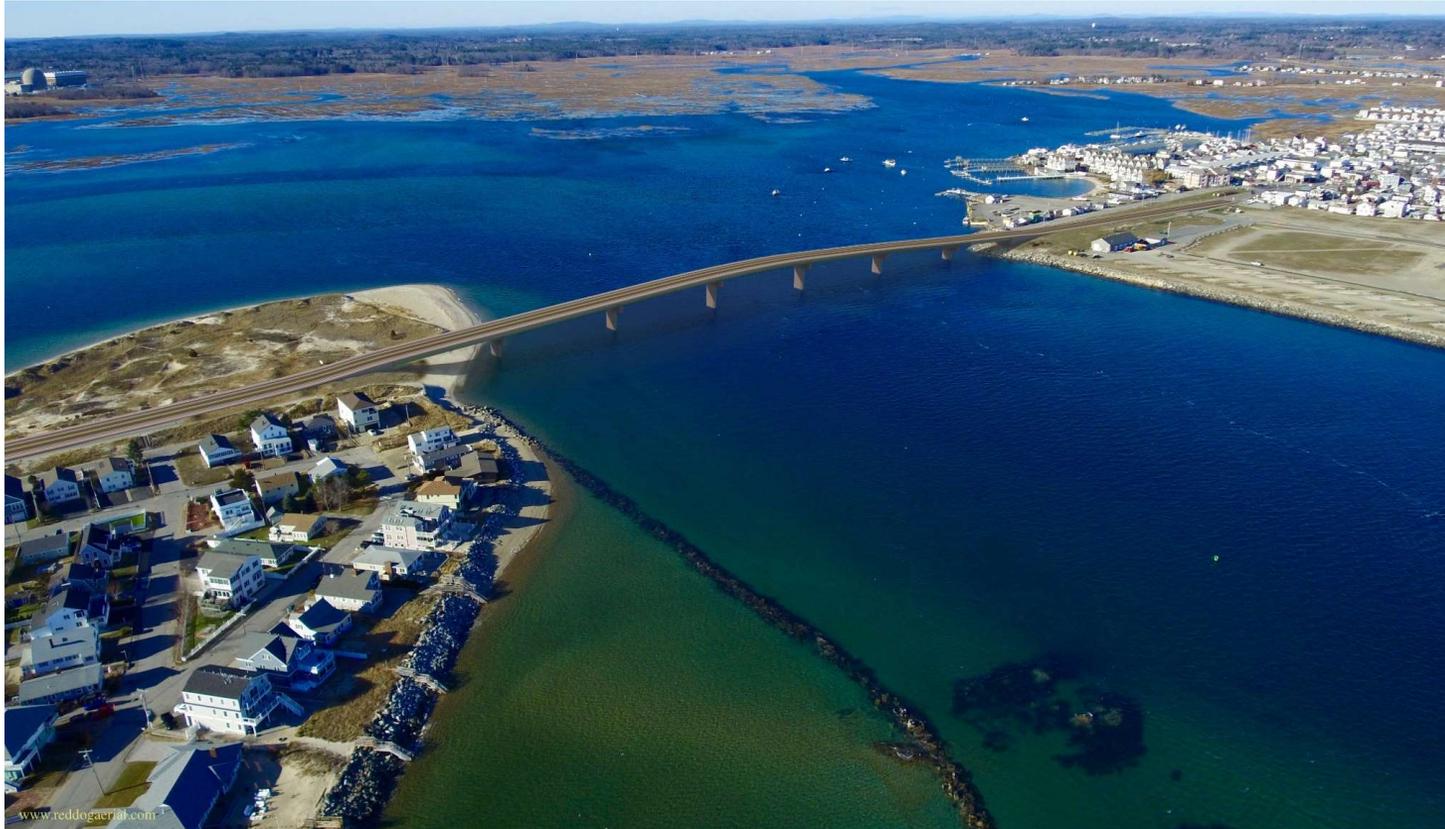
Aerial of Proposed Fixed Bridge

- Provides improved underclearance for vessels
 - ▶ Clears at least 90% of current lifts
 - ▶ Clears all regular users
 - ▶ Provides significant improvement for horizontal clearance – 150'
 - ▶ Clears USACE dredge equipment at low tide
- No bridge lifts required with fixed structure
- Provides acceptable roadway grade – 5% slope
- Balances impacts on approaches
 - ▶ Height increase at abutment: 10'±
- Fixed Bridge - significantly reduced capital and life cycle costs compared to a bascule bridge
- Bridge can be designed to carry utilities across the harbor

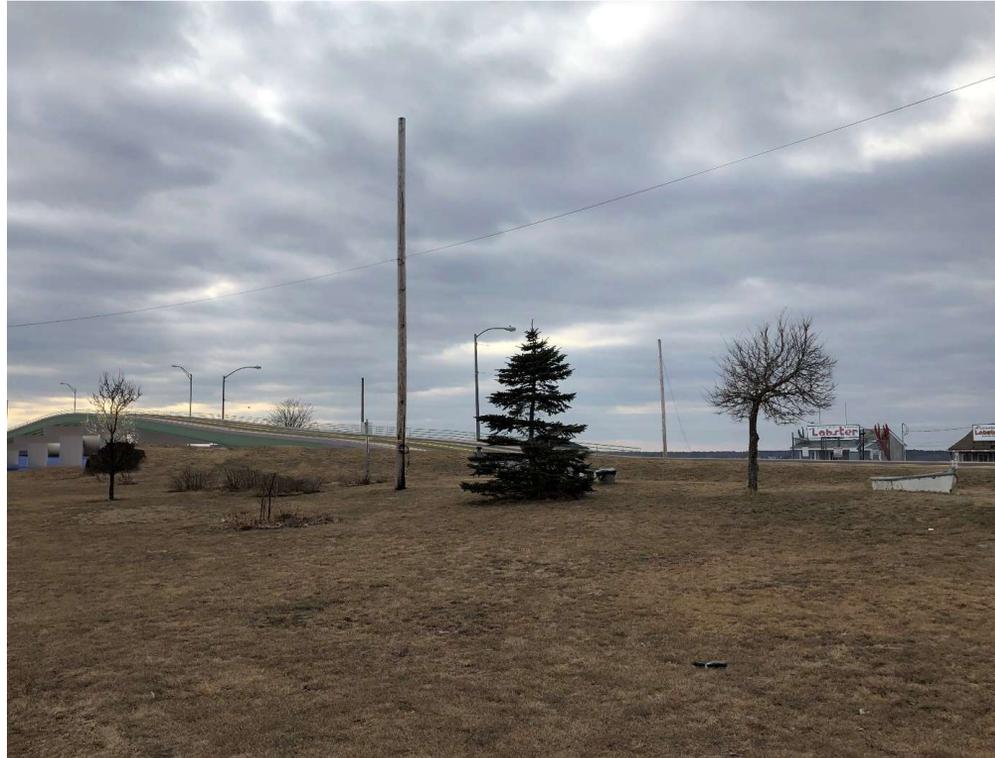
Looking Southwest at North Approach – Proposed Fixed Bridge

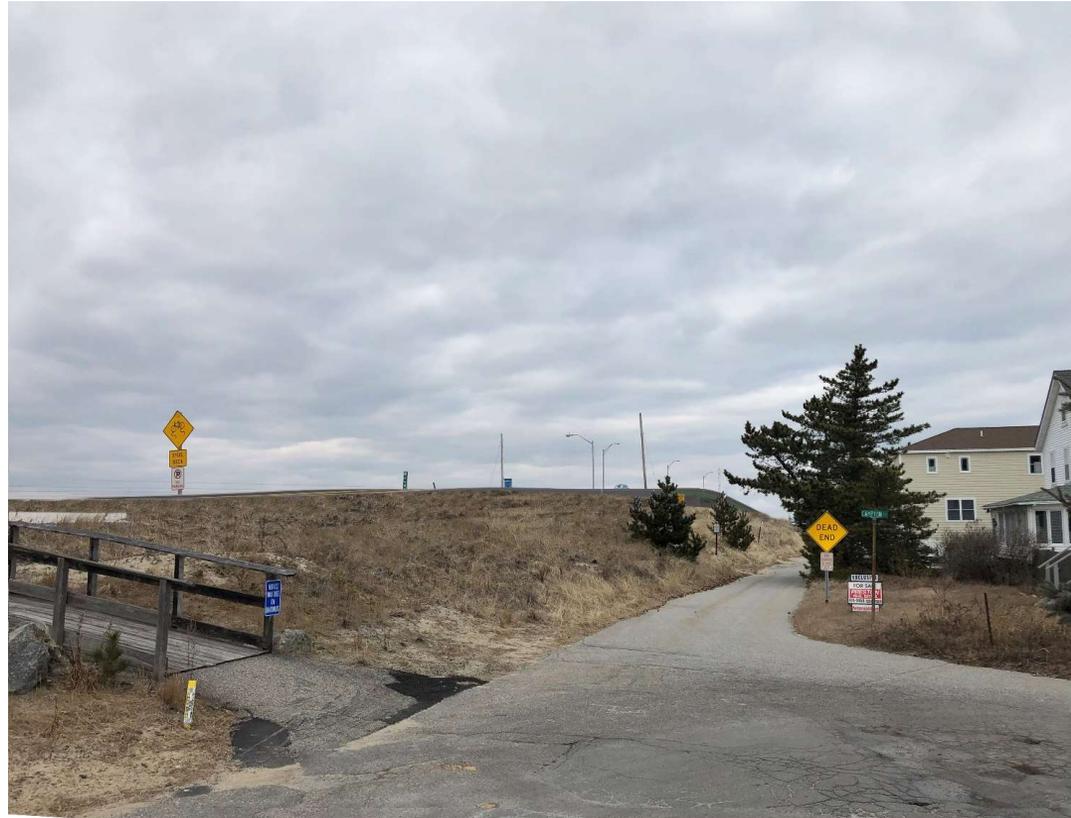
Looking West at South Approach
